Final Asbestos Survey Update Report
Gallagher Memorial USAR Center (NM005)
1300 West Brown Road, Las Cruces, New Mexico 88005

Contract No. W912QR-12-D-0027
Delivery Order No: 0003

July 2013

4.0 FINDINGS OF THIS RE-INSPECTION

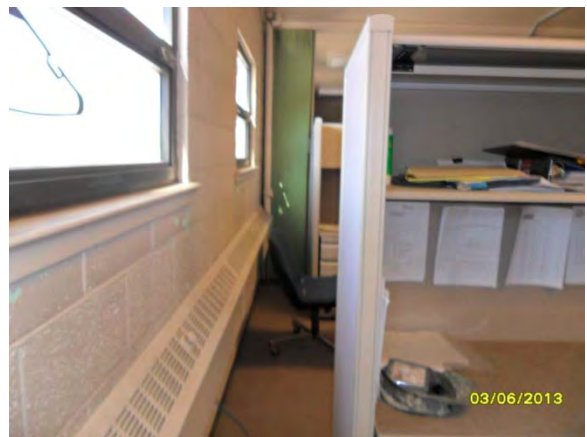
- Rooms 104 and 105 in the Administration Building were locked at the time of the inspection, although portions of the rooms could be observed through in-door windows, and appeared to remain as described in previous reports; and
- Room 111 in the Administration Building was carpeted. Materials under the carpeting could not be observed.

A-18. Administration Building, Room 111.

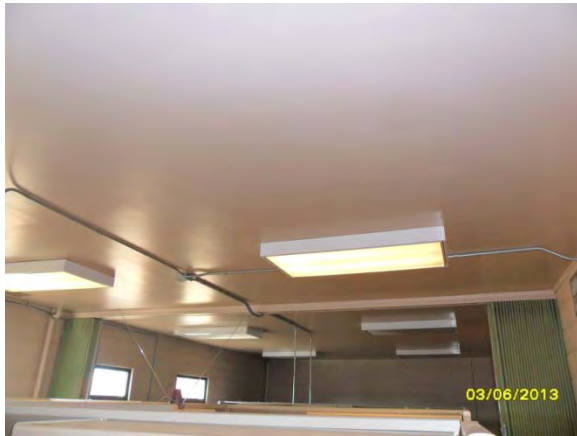
A-19. Administration Building, Room 111.

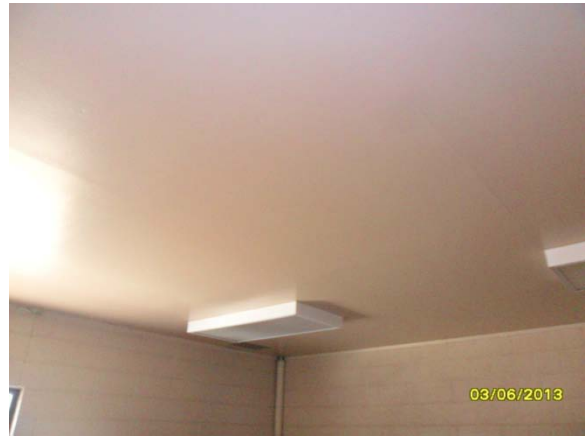
A-20. Administration Building, Room 111.

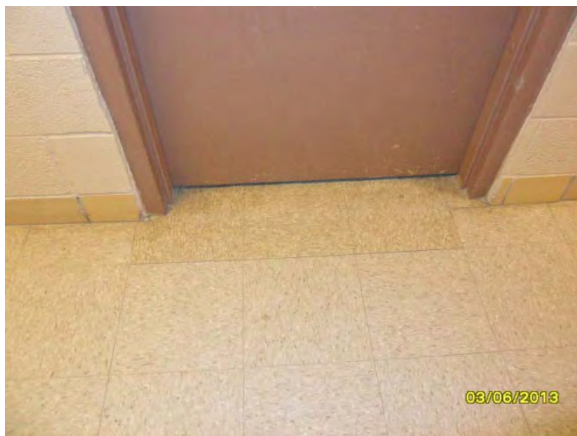
**A-23. Administration Building, VCT Types Outside
Utility Closet, Main Hallway Room 102, Outside
Room 112.**

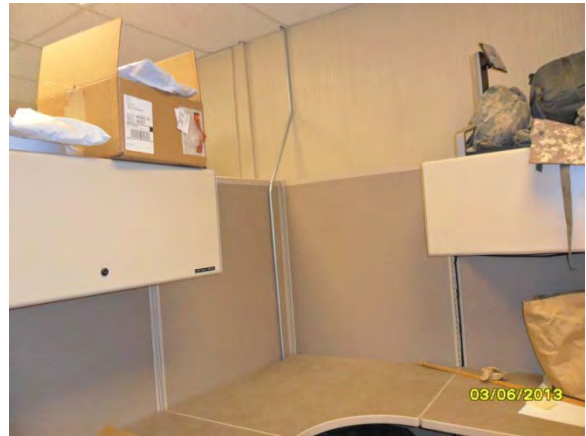
The 1993 asbestos survey (DECAM 1993) indicated the presence of ACM at the site in vinyl composition tile (VCT) adhesives in the Administration Building, Room 114. Remaining materials sampled, including roofing materials, wall and ceiling components, VCT systems (VCT, coving, and related mastic) and Thermal System Insulation in both the Administration Building and the OMS were reported as non-ACM. The 1997 asbestos re-inspection report (90th RSC 1997) confirmed the presence of ACM and noted that flexible duct connectors (vibration collars) on the Heating, Ventilation, and Air Conditioning (HVAC) air handlers in the Assembly Hall of the Administration Building were assumed to be ACM. The 2011 survey (L&P 2011) was limited to the OMS storage area. The report indicates that samples of VCT and mastic were obtained for laboratory analysis, with no ACM detected.

A-26. Administration Building, Room 114.

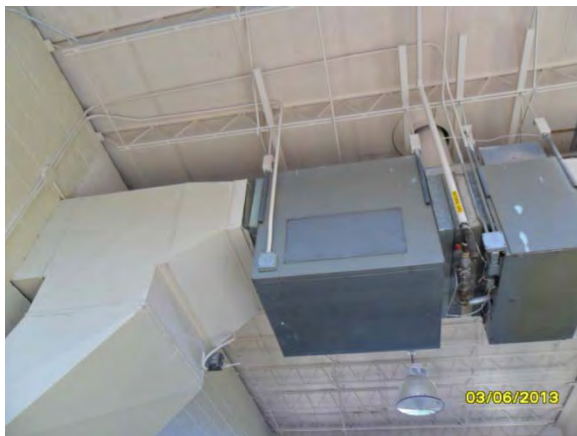
Friable assumed ACM was noted in the vibration collars on the HVAC air handling units in the Administration Building Assembly Hall. Friable ACMs were not observed in the remainder of either building. Table 4-1 includes a summary of the previous and current conditions of the identified ACMs. Materials sampled in the 1993, 1997, and 2011 surveys that were found not to be ACM are not included in Table 4-1.

**A-33. Administration Building, Assembly Hall,
Room 120, Southwest HVAC Unit.**

- Suspect ACM should be sampled and evaluated prior to disturbance during operation and maintenance or renovation, as needed;
- ACM should remain covered or properly maintained to prevent abrasion, chipping or cracking, to minimize potential for exposure; and
- Should ACM be scheduled for removal, follow all local, state and federal regulations, using appropriate containment protocols and properly licensed and certified asbestos abatement contractors and supervision.

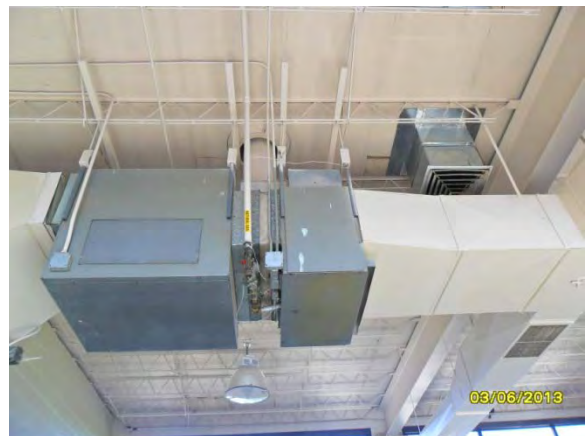
**A-34. Administration Building, Assembly Hall,
Room 120, Northeast HVAC Unit.**

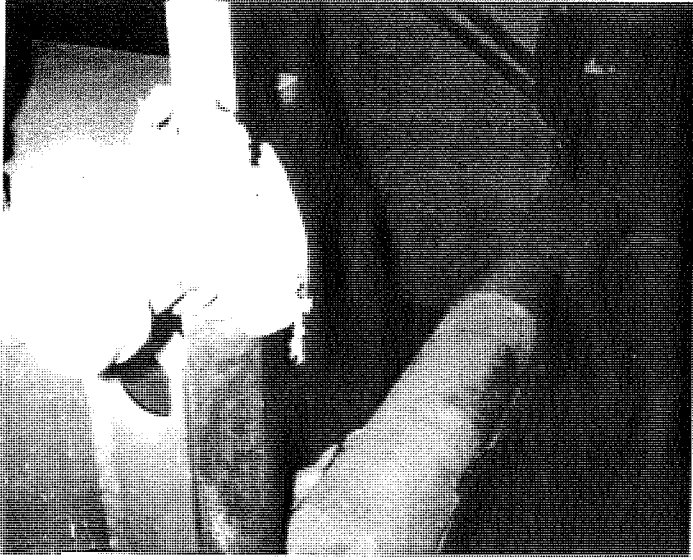
**PHOTO NUMBER
01**

SAMPLE NO.	ACM LC-001	ACM LC-002	ACM LC-003	ACM LC-004	ACM LC-005
LOCATION	MECH ROOM	MECH ROOM	RM 120	RM 120	RM 114
TYPE OF MATERIAL	PF	PI	FTM	BCM	FTM
PHOTO NO.	01	02	03	03	04
FUNCTIONAL SPACE NO.	01	01	02	02	03
CONDITION:					
% DAMAGE					0
EXTENT					D
TYPE					P
POTENTIAL DISTURBANCE:					
AIR					L
VIBRATION					L
CONTACT					L
QUANTITY					1400 SF
RESULTS	N	N	N	N	MASTIC 10-20% CHRY
