Asbestos Re-Inspection Report

IRS Building
173 East 100 North
Provo, Utah
GSA Building No. UT0039ZZ

IRS Building
175 East 100 North
Provo, Utah
GSA Building No. UT0039ZZ

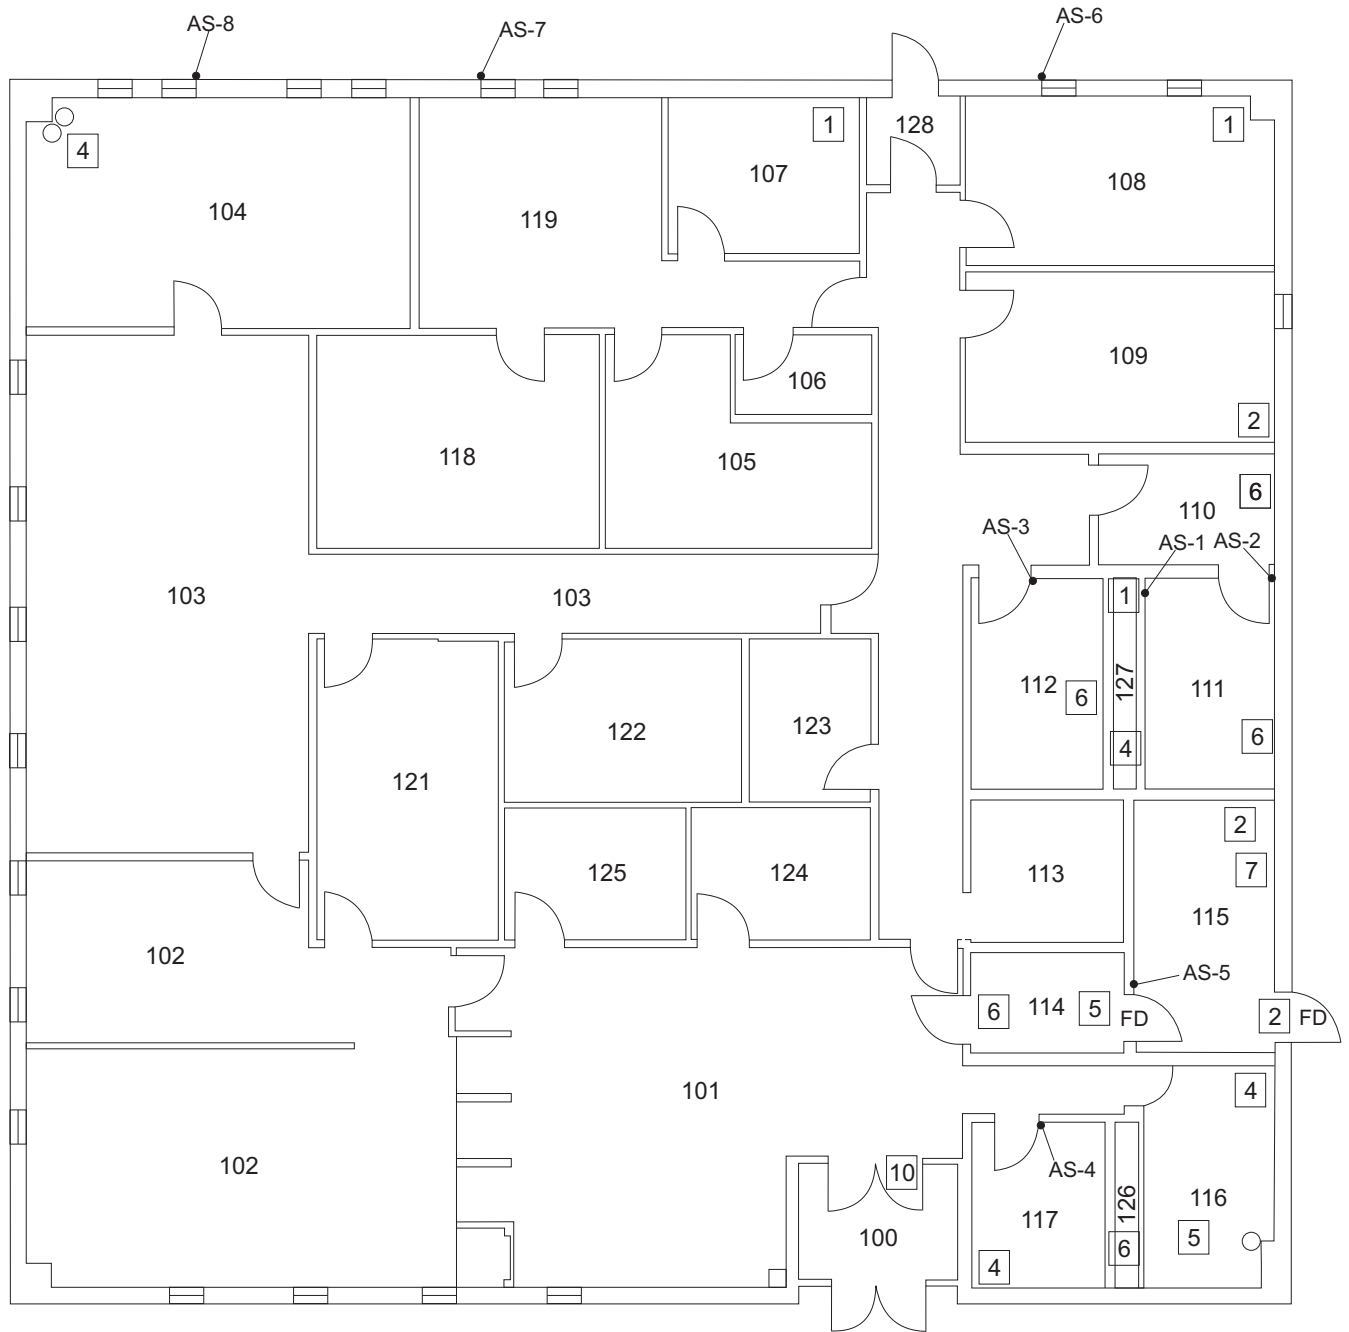
First Floor Figure 1

- 5 Asbestos-containing Mudded Elbow Location and Quantity
- Asbestos-containing Roof Drain Location
- 2014 Asbestos Sample Location (AS-x)
- FD Asbestos-containing Fire Door

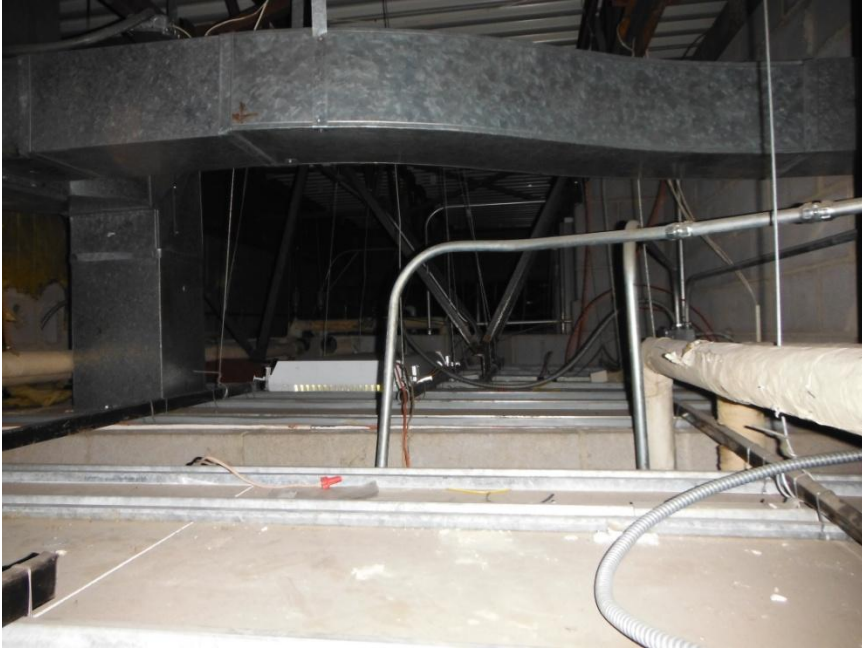
Photo 1. Typical asbestos-containing mudded elbow

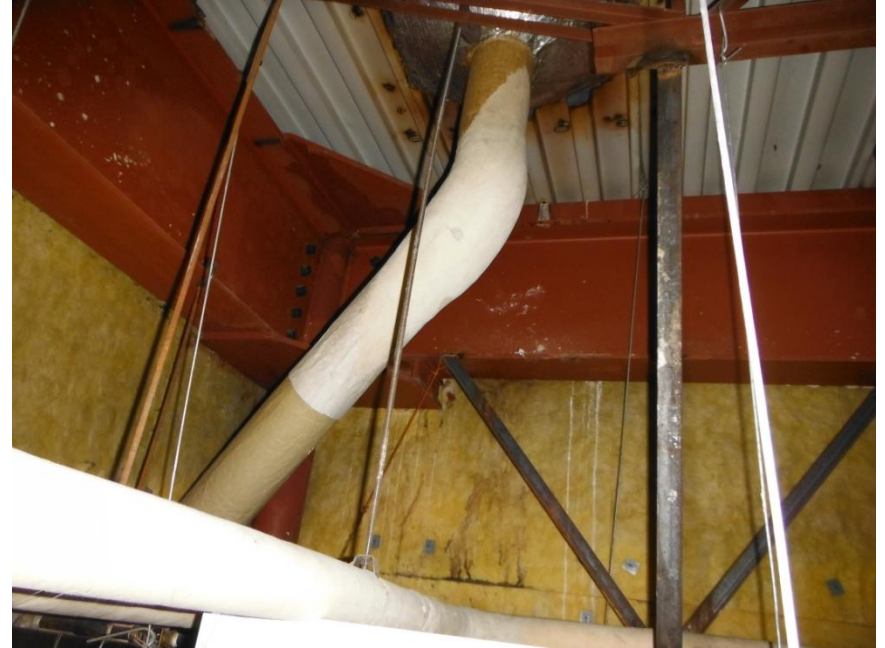
Photo 2. Typical asbestos-containing mudded roof drain
