LIGHTHOUSE INSPECTION REPORT
SECTOR MARYLAND-NCR
ANT CRISFIELD
HOOPER ISLAND LIGHTHOUSE
LLNR 7590

Structure Type: White conical tower on brown cylindrical base. Advertised focal plane height of 63 feet.

Inspection: The inspection was performed on July 9, 2019 by CWO Runt of Sector Maryland-NCR and BMC Durfee of ANT Crisfield.

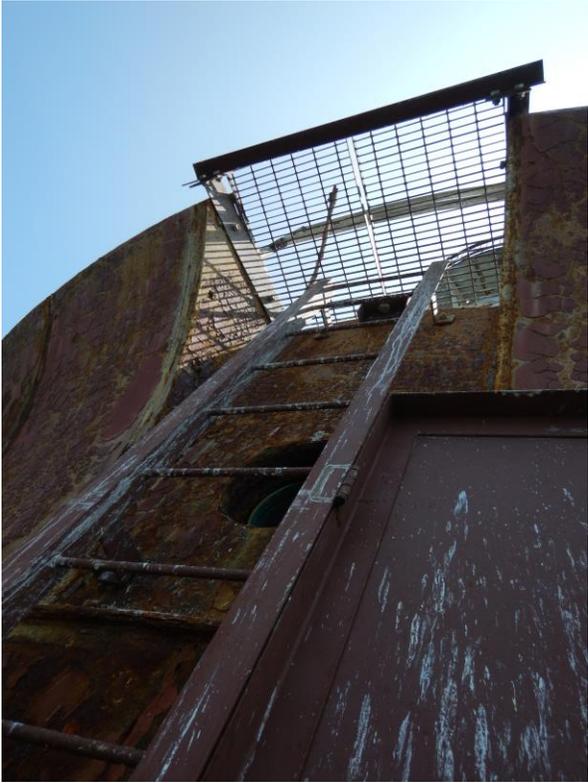
Locked access gate

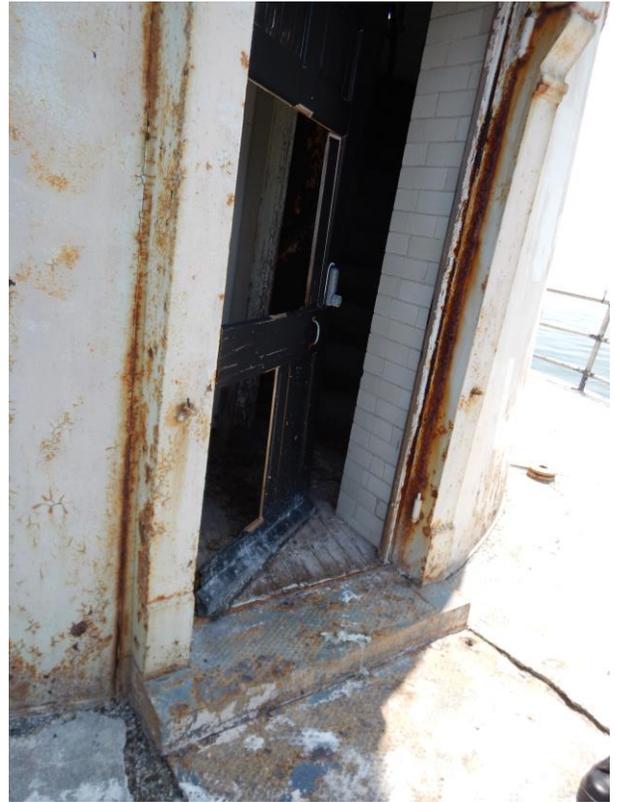
Findings: Fair condition, but approaching poor. The main door to the structure is missing, allowing vandals and wildlife unobstructed entry to the structure. The main access ladder from the water is in good condition and the access hatch is locked. Walking surfaces on the top of the caisson are in good condition as is most of the surfaces within the tower. The largest problems were found to be a panel failing on the exterior, the exterior coating and the missing door. This lighthouse would be in good condition if not for those discrepancies. The structure was last inspected by Tower Inspection in September 2015 for the CEU structural inspection required to be completed every five years.

Broken door

2. Replace the broken/missing door with one that is capable of withstanding weather and vandals. This is to protect not only the structure, but also the CG owned equipment housed within the lighthouse not only from vandals, but also wildlife.
3. The owner needs to remove scaling and rust in an approved manner and paint the caisson to protect the structure base. The lighthouse tower also requires the same to protect the tower and to provide the advertised characteristic of a white tower. Much of the tower is rust colored and will worsen with the passage of time.
4. Decking on the fourth deck is missing planks as is the overhead. This was caused by water penetration a number of years ago, but the source has been repaired.
5. Keep the structure secure to prevent further birds from entering and dying within the structure.

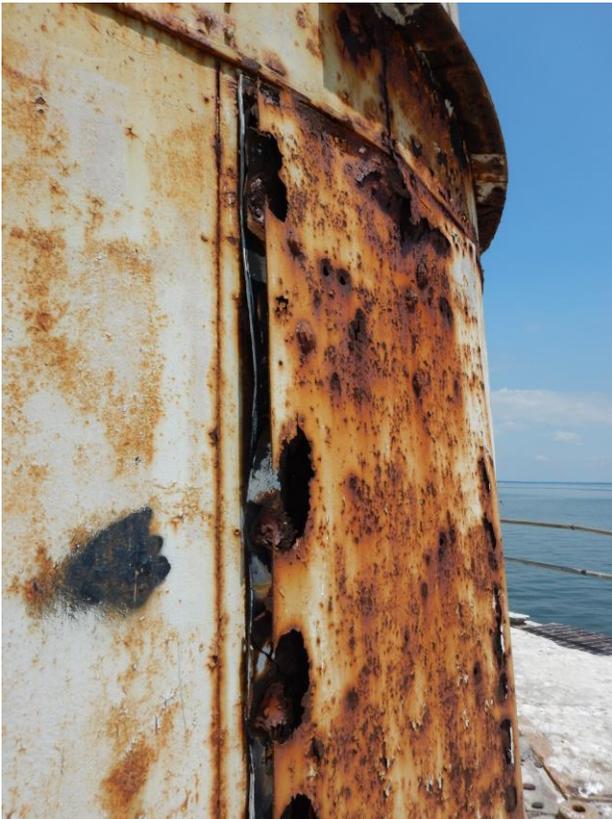
Failing panel

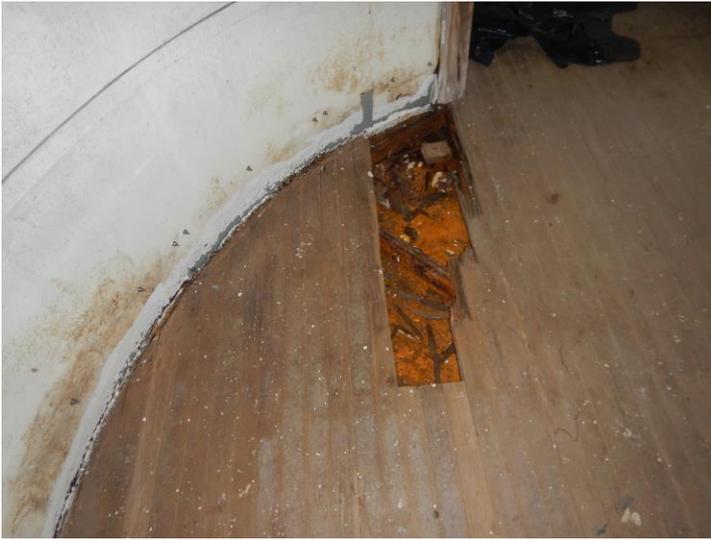
04 Deck (missing flooring planks)

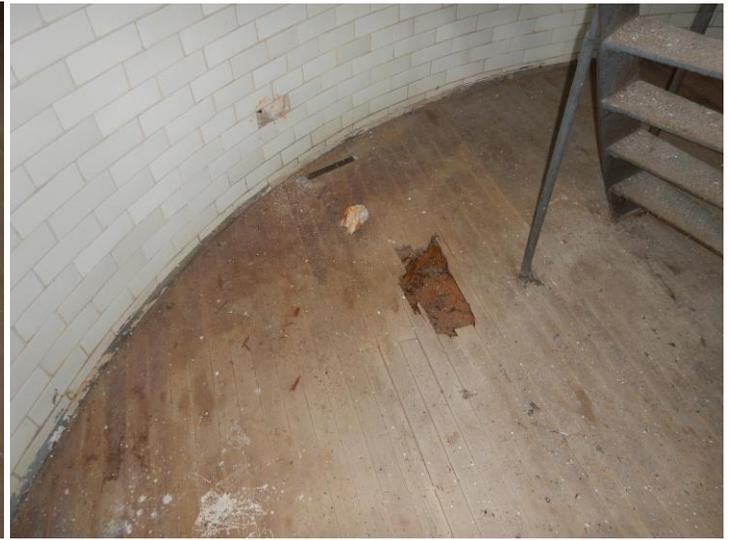
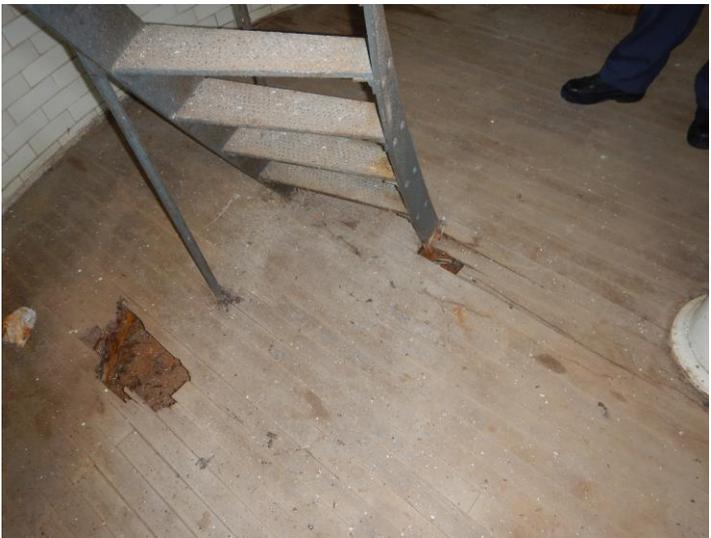
04 Deck (missing flooring planks)

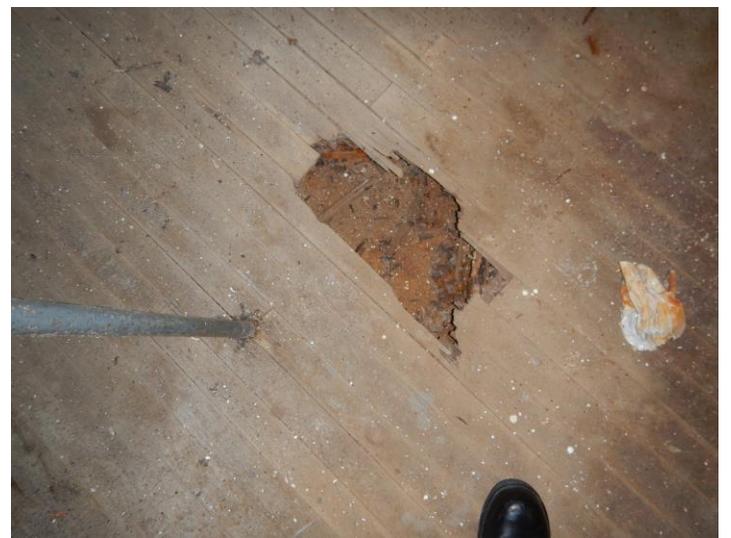
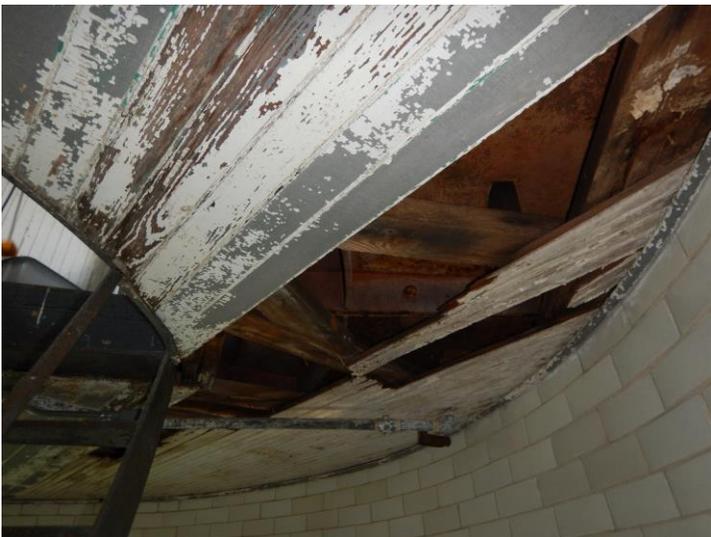
04 Deck (missing overhead planks)

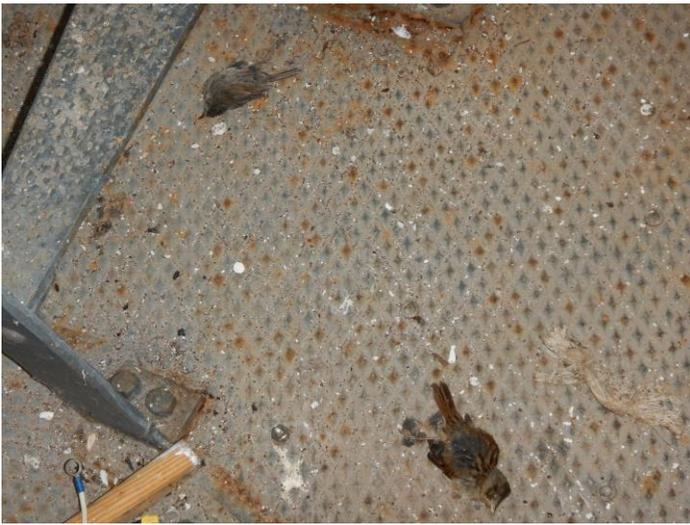
05 Deck (dead birds)
