ASBESTOS RE-INSPECTION SURVEY REPORT

FEDERAL BUILDING AND U.S POST OFFICE
GSA BUILDING NUMBER WA0082ZZ
301 YAKIMA STREET
WENATCHEE, WASHINGTON 98801

ASSESSMENT DATE
SEPTEMBER 24, 2012

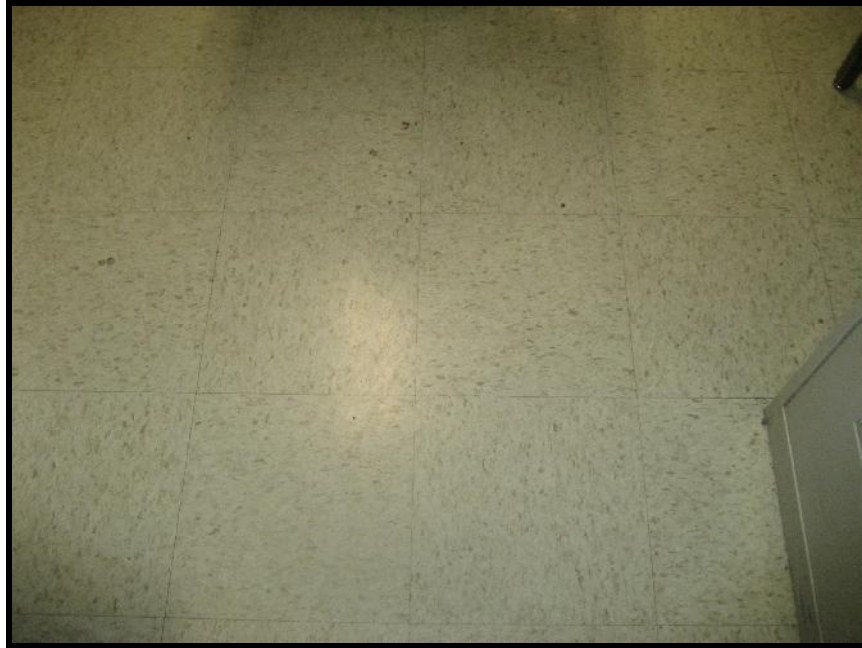
PHOTOGRAH 1

Floor Tile 12" x 12" and associated mastic -Both the 12" x 12" white floor tile and associated black mastic are located in the throughout ground floor (basement) under carpet tiles and throughout the 2nd and 3rd floors above concrete floors. The material was sampled and analyzed for asbestos content during a previous survey. The floor tile and mastic are considered non-friable and in good condition. The floor tile and mastic are located in high use areas of the facility but presents a low health hazard potential to building occupants due to a minimal potential for disturbance and fiber release. This building material is assigned a response action of 7 because it is a non-friable material not requiring repair and the limited access. This asbestos-containing floor tile and mastic should be placed in an Operations and Maintenance program until renovation or demolition activities require removal.

Floor Tile 12" x 12" white and associated black mastic
Please see initial lab report for percentage and type of asbestos for this ACM material

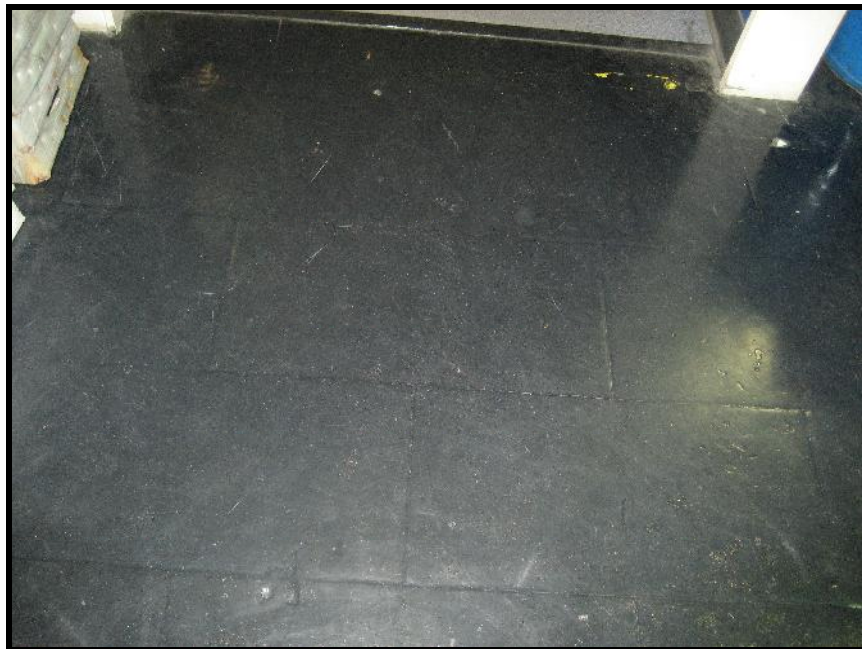
PHOTOGRAH 2

Floor Tile 12" x 24" and associated mastic -Both the 12" x 24" black floor tile and associated black mastic are located in the throughout the postal work area and the mezzanine above the postal area. The material was sampled and analyzed for asbestos content during a previous survey. The floor tile and mastic are considered non-friable and in good condition. The floor tile and mastic are located in high use areas of the facility but presents a low health hazard potential to building occupants due to a minimal potential for disturbance and fiber release. This building material is assigned a response action of 7 because it is a non-friable material not requiring repair and the limited access. This asbestos-containing floor tile and mastic should be placed in an Operations and Maintenance program until renovation or demolition activities require removal.

Floor Tile 12" x 24" black and associated black mastic
Please see initial lab report for percentage and type of asbestos for this ACM material

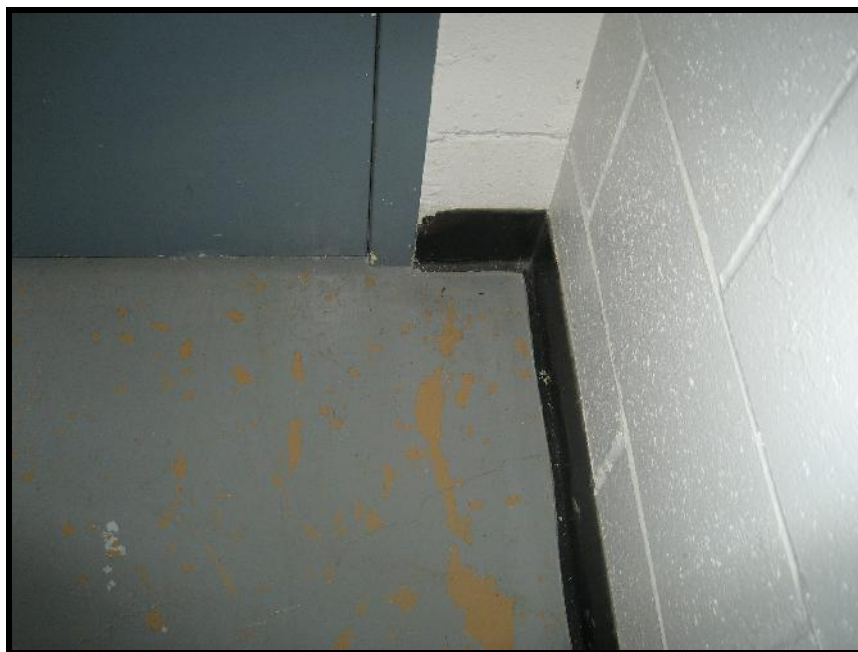
PHOTOGRAPH 4

Fire Doors – The fire doors were not sampled due to the sampling being too destructive, therefore, the fire doors are assumed to be ACM. The fire doors are located in high use areas of the facility but present a low health hazard potential to building occupants due to a minimal potential for disturbance and asbestos fiber release. This building material is assigned a response action of 7 because it is a non-friable material not requiring repair. This assumed asbestos-containing fire door should be placed in an Operations and Maintenance program unless testing determines it to be non ACM or until renovation or demolition activities require removal.

Fire Doors
Assumed ACM
