**VOLUME II
ASBESTOS CONTAINING MATERIAL
SURVEY REPORT
RESIDENTIAL VETERAN HOUSING
BROWNELL HOUSE
NEW HAVEN, CT**

**VISN 1
West Haven VA Medical Center
950 Campbell Avenue
West Haven, Connecticut**

Project No. 2009023.006

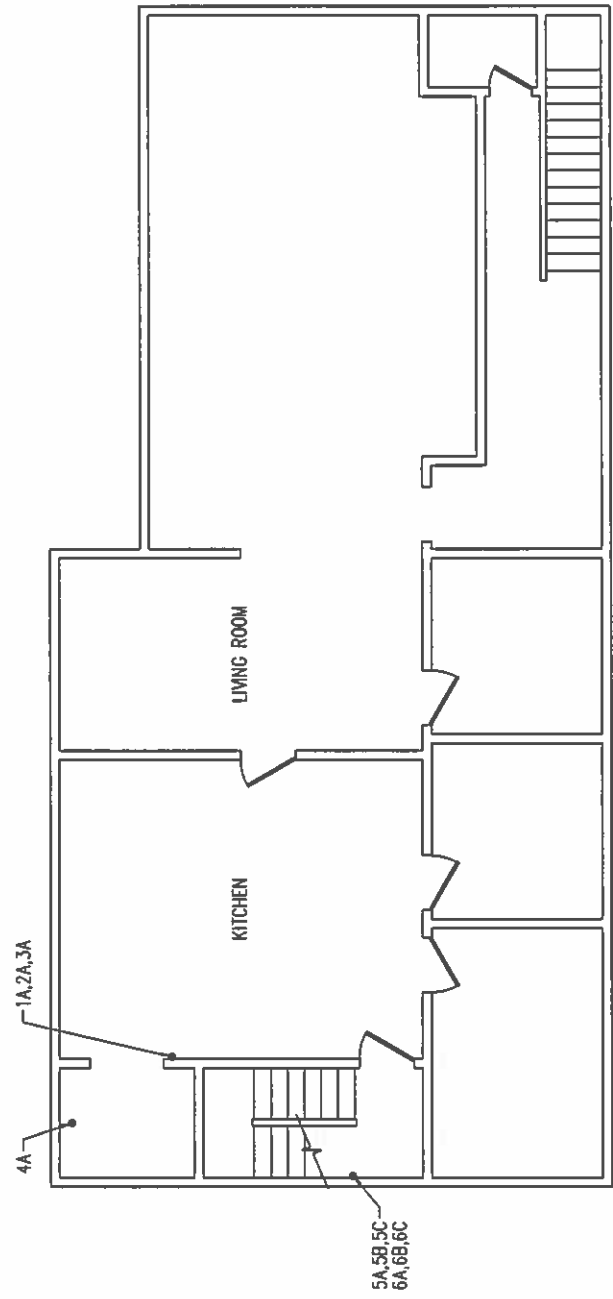
ASBESTOS SURVEY SUMMARY PLAN

Brownell House		DATE: APRIL 2011	
FIRST FLOOR		SCALE: 1/8" = 1'-0"	
PROJECT: ASBESTOS SURVEY		SHEET: 1 OF 1	
CLIENT: []	CONTRACT: []	DATE: []	BY: []
DRAWN BY: []			
CHECKED BY: []			
DATE: []

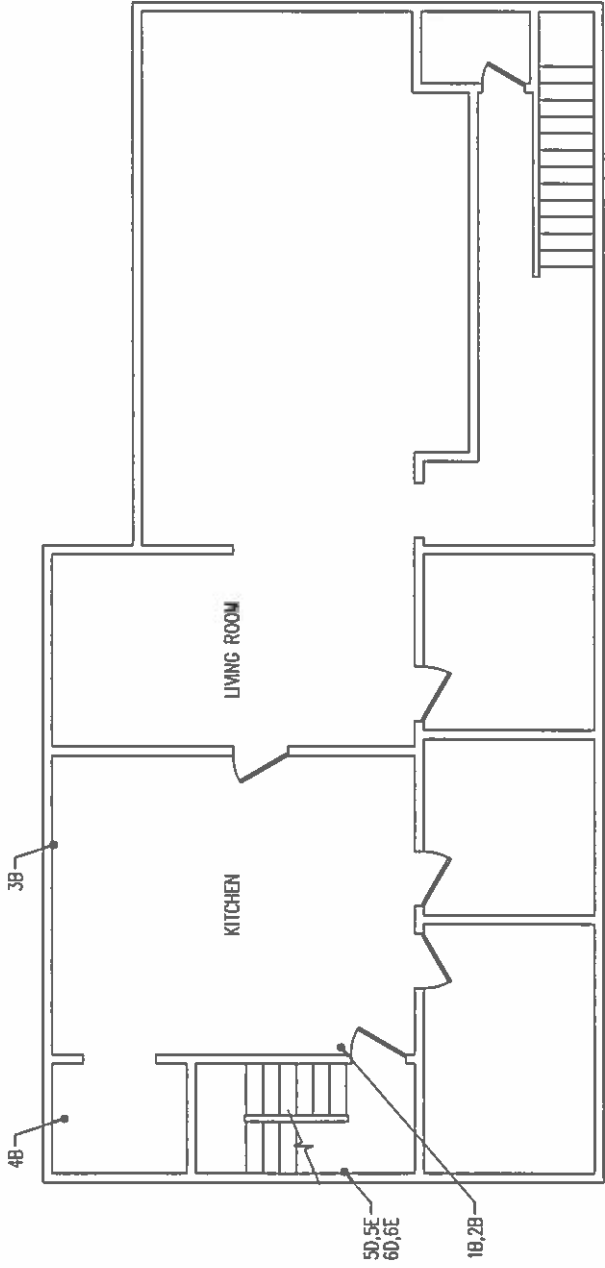
ASBESTOS SURVEY SUMMARY PLAN

Project No. BROWNELL HOUSE	Project No. ASBESTOS SURVEY	Date APRIL 1981	Scale 1/4" = 1'-0"
Client SECOND FLOOR	Client SHAW-WALKER	Sheet No. 2	Total Sheets 1
Location NEW HAVEN, CT	Inspector W.P.	Project W.P.	Scale 1/4" = 1'-0"

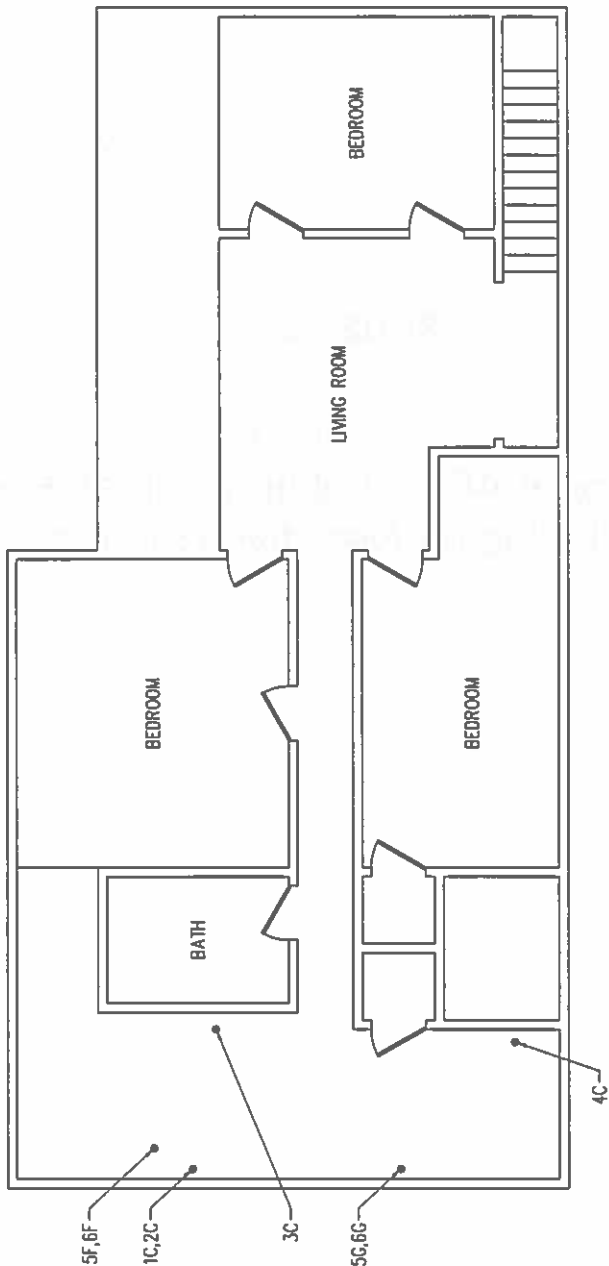
ASBESTOS SURVEY SUMMARY PLAN

Project No. BROWNELL HOUSE		Project Name ASBESTOS SURVEY		Date APRIL 2011	Page 3 of 1
Floor THIRD FLOOR		Client UNIVERSITY OF MARYLAND	Inspector DAVID J. BROWNELL	Scale AS SHOWN	Sheet No. 3
Scale AS SHOWN		City ANNAPOLIS, MD		State MARYLAND
