**PHASE II ENVIRONMENTAL SITE ASSESSMENT
OF
THE HYBLA VALLEY OFFICE BUILDING
(VA0085ZZ)**

**6801 TELEGRAPH ROAD
ALEXANDRIA, VA 22310**

October 21, 2014

**Phase II Environmental Site Assessment
Hybla Valley Office Building
(VA0085ZZ)
6801 Telegraph Road
Alexandria, Virginia**

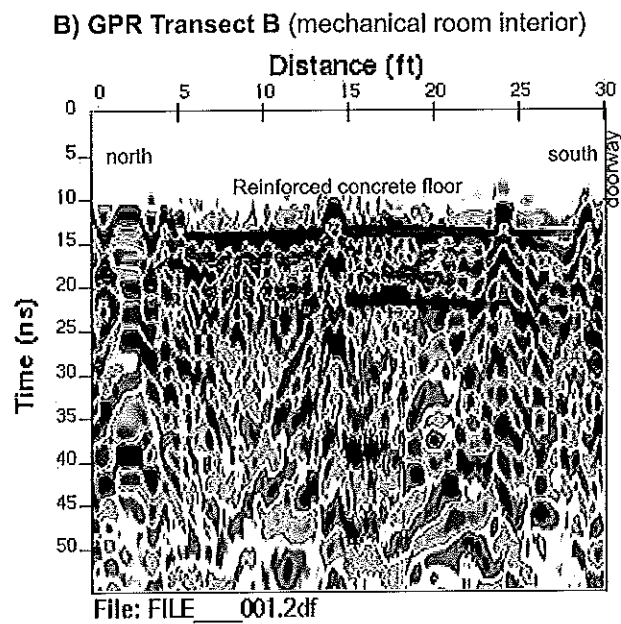
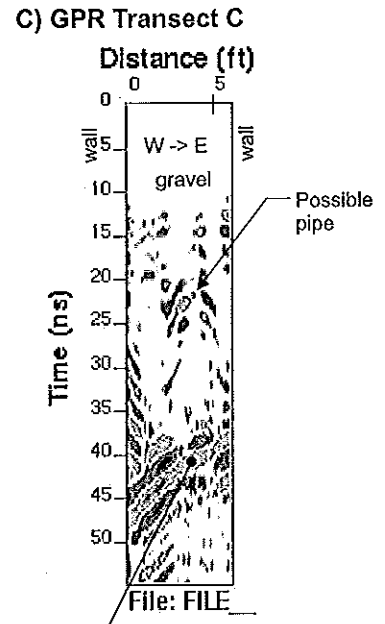
The overall GPR response observed during the survey showed moderate to strong signal attenuation effects. The strong signal attenuation effects suggest the presence of higher conductivity wet clay and silt in the shallow subsurface soil and fill, which is common in this region of Virginia. The lower signal attenuation effects below the mechanical room floor suggests greater amounts of sand and gravel subgrade below the floor slab. The GPR depth of exploration probably did not exceed 3-ft to 4-ft throughout the areas of investigation, and could be less in areas where higher amounts of wet silt and clay, reinforced concrete, or other complicating near-surface conditions or obstructions are present. The depth of exploration for the EM instrumentation is on the order of 15-ft to 20-ft.

Notes:
 GSSI SIR-3000GPR system w/ 270 MHz & 400 MHz antennae
 512 samples/trace; ~ 10 traces/ft
 Survey date: September 10, 2014
 Refer to Figure 1 for GPR transect locations
