ASBESTOS INVESTIGATION REPORT

Umpqua National Forest
2900 N. W. Stewart Parkway
P. O. Box 1008
Roseburg, OR 97470

COTTAGE GROVE R.S.

November 30, 1992

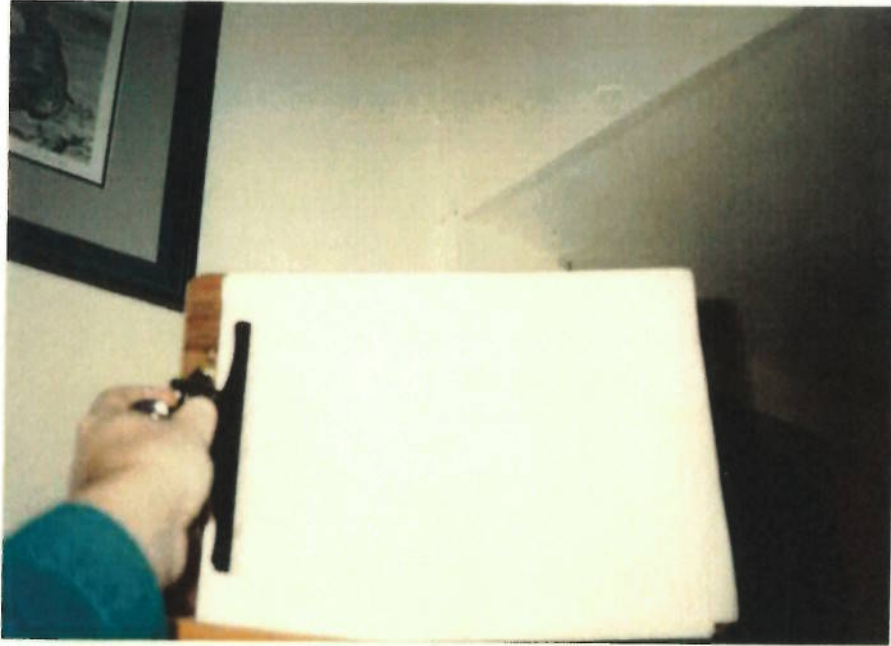
Sample #390

SAMPLE #	PARAMETER	ANALYSIS	MATERIAL DESCRIPTION
443. UMP-02-390 Tape Cmpd	Asbestos	None Detected	Sample Color - White This material contains approximately <1% Cellulose, 2% Quartz, 5% Mica, 80% Calcite, 13% Particulate Matter
444. UMP-02-391 Shingle	Asbestos	None Detected	Sample Color - Brown/Black This material contains approximately 15% Fiberglass, 1% Quartz, 1% Mica, 20% Calcite, 63% Particulate Matter
445. UMP-02-392 Felt	Asbestos	None Detected	Sample Color - Black This material contains approximately 80% Cellulose, 20% Particulate Matter

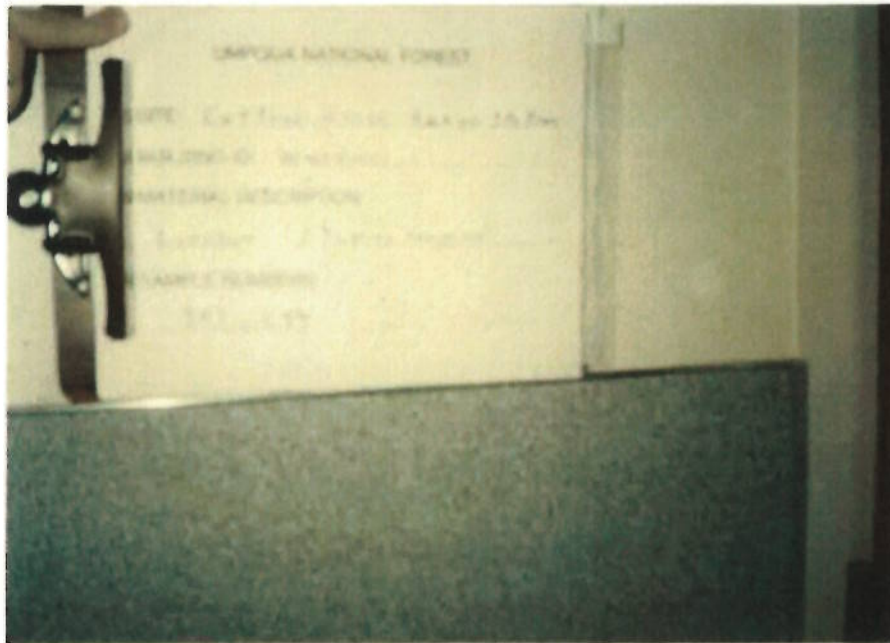
Sample #'s 393 & 394

<u>Homogeneous Area</u>	<u>Sample Number</u>	<u>Material Description/Location</u>
HA-01	UMP-02-393	Linoleum - Blue
HA-02	UMP-02-394	Wallboard & Taping Compound
HA-03	UMP-02-395	Shingle
HA-04	UMP-02-396	Felt under Shingle

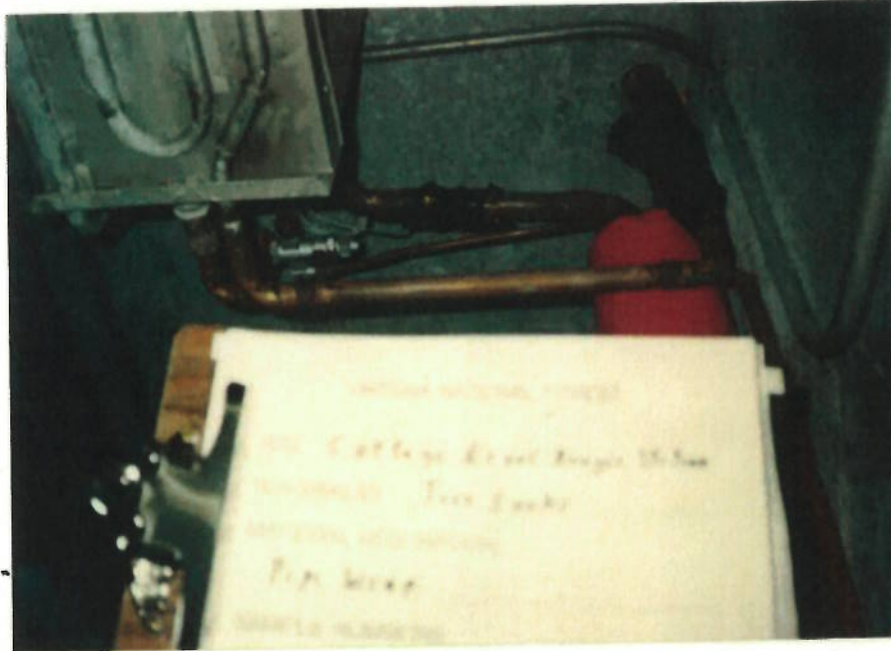
Sample #397

<u>Homogeneous Area</u>	<u>Sample Number</u>	<u>Material Description/Location</u>
HA-01	UMP-02-397	Tar Insulation
HA-02	UMP-02-398	Shingle
HA-03	UMP-02-399	Felt under Shingle
