ATTACHMENT B

LBP SURVEY MAPS

LBP Survey Map
US Coast Guard Housing Unit
2 -8 Harriett Lane
Palermo, New Jersey

RESULTS OF LEAD-BASED PAINT INSPECTION:

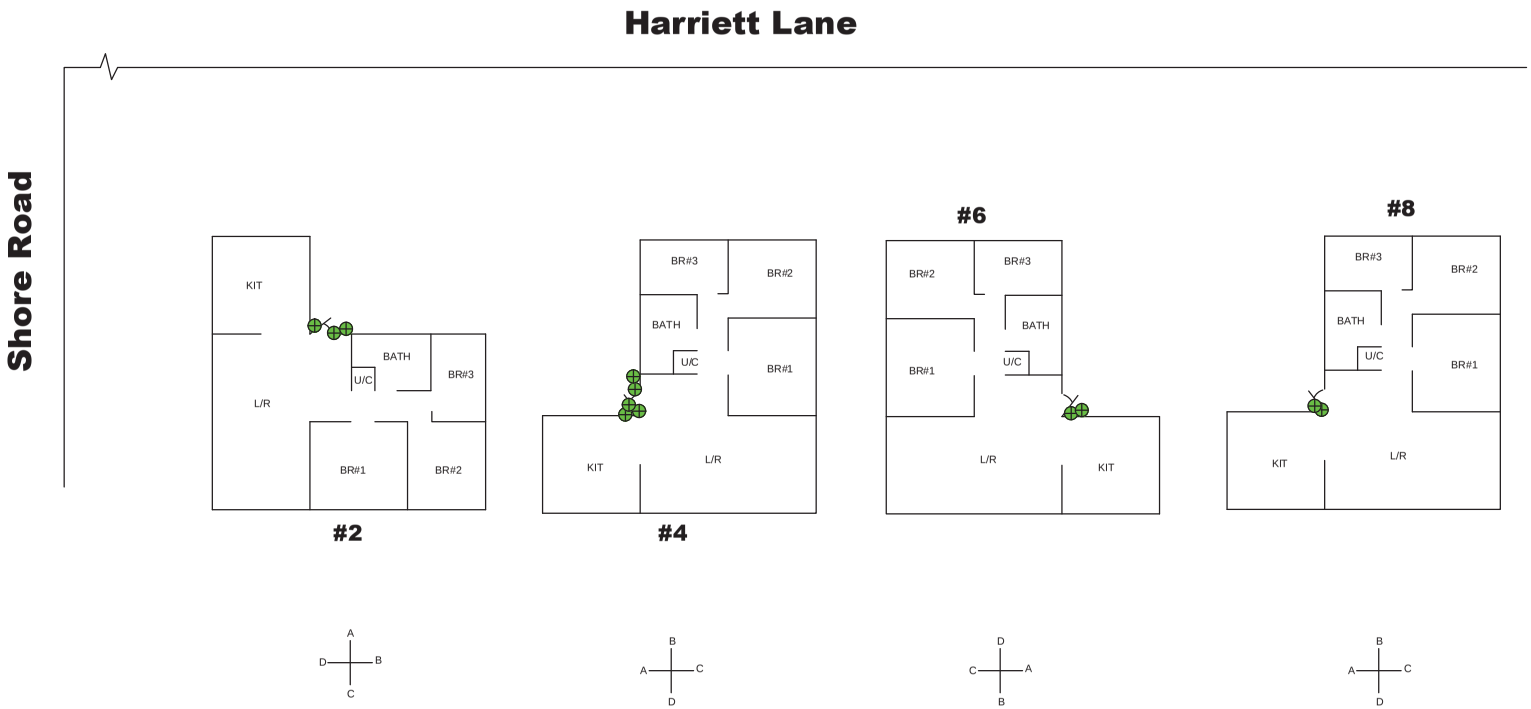
Lead-Based Paint Testing Location Exceeding Criteria

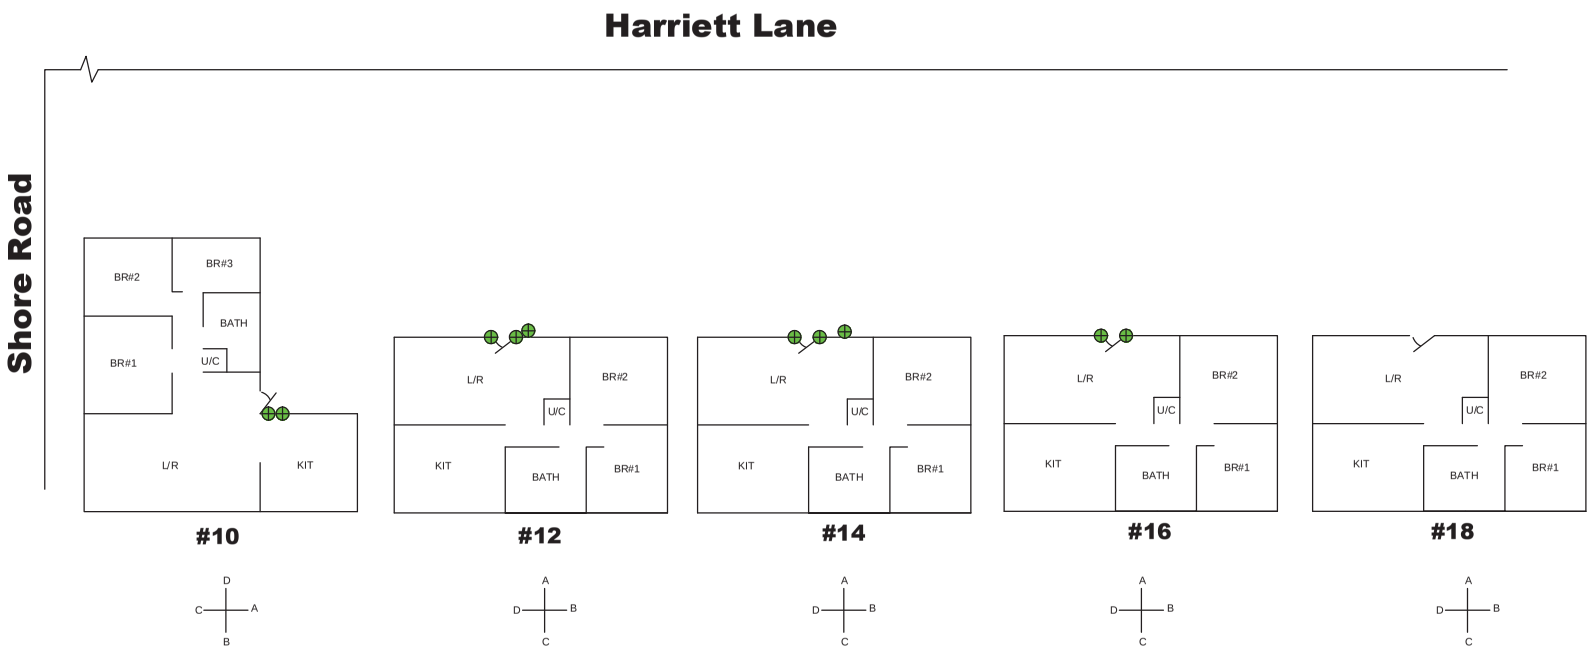
LBP Survey Map
US Coast Guard Housing Unit
10 -18 Harriett Lane
Palermo, New Jersey

⊕ Lead-Based Paint Testing Location Exceeding Criteria

Building	Reading No.	Level	Room #	Room Location	Wall	Component	Subcomponent	Substrate	Color	Condition	Result	Lead (mg/cm^2)
2 Harriet Lane	4	1st Floor	1	Kitchen	A	Wall		Drywall	White	Fair	Negative	-0.5
10 Harriet Lane	**57**	**Exterior**		**Entry**	**B**	**Door Component**	**Jamb (latch side)**	**Wood**	**White**	**Fair**	**Positive**	**1.0**
10 Harriet Lane	**58**	**Exterior**		**Entry**	**B**	**Door Component**	**Casing/Trim**	**Metal**	**White**	**Fair**	**Positive**	**6.0**
12 Harriet Lane	**57**	**Exterior**		**None**	**C**	**Door Component**	**Jamb (latch side)**	**Wood**	**White**	**Fair**	**Positive**	**3.3**
12 Harriet Lane	**58**	**Exterior**		**None**	**C**	**Door Component**	**Casing/Trim**	**Metal**	**White**	**Fair**	**Positive**	**2.2**
12 Harriet Lane	**59**	**Exterior**		**None**	**C**	**Door**		**Wood**	**White**	**Fair**	**Positive**	**4.7**
14 Harriet Lane	**52**	**Exterior**		**None**	**C**	**Door**		**Wood**	**White**	**Fair**	**Positive**	**1.6**
