Final Asbestos Survey Update Report
Gallagher Memorial USAR Center (NM005)
1300 West Brown Road, Las Cruces, New Mexico 88005

Contract No. W912QR-12-D-0027
Delivery Order No: 0003

July 2013

4.0 FINDINGS OF THIS RE-INSPECTION

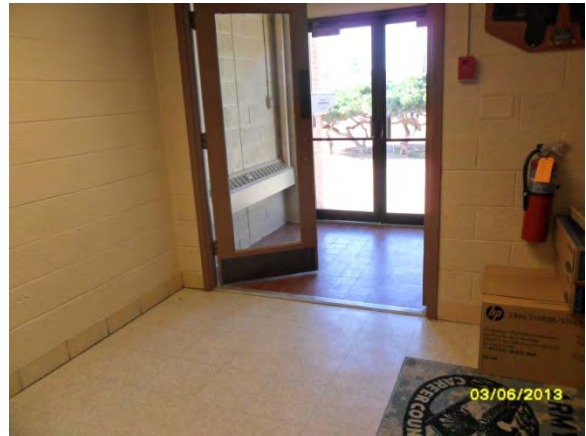
A-8. Administration Building, Front Entry, Hallway 101.

Administration Building				
Room	Material Type	Color	Condition	Comment
101	VCT (hallway): Ceramic Tile (entrway)	VCT (light toast): Ceramic Tile ('brick red')	Undamaged, Non-Friable	Typical of VCT throughout majority of the facility. Non-ACM.
102	VCT	Light toast	Undamaged, Non-Friable	Typical of VCT throughout majority of the facility. Non-ACM.
103	VCT	Tan with black mottling	Undamaged, Non-Friable	Typical of VCT in Hallway 103 and Assembly Hall Room120. Non-ACM.
104	VCT	Light toast	Undamaged, Non-Friable	Typical of VCT throughout majority of the facility. Non-ACM.
105	VCT	Light toast	Undamaged, Non-Friable	Typical of VCT throughout majority of the facility. Non-ACM.
106	Ceramic Tile	Gray, blue, white tiles	Undamaged, Non-Friable	Women's showers, non-ACM.
107	Ceramic Tile	Gray, blue, white tiles	Undamaged, Non-Friable	Women's latrine, non-ACM.
108	Ceramic Tile	Gray, blue, white tiles	Undamaged, Non-Friable	Women's locker room, non-ACM.

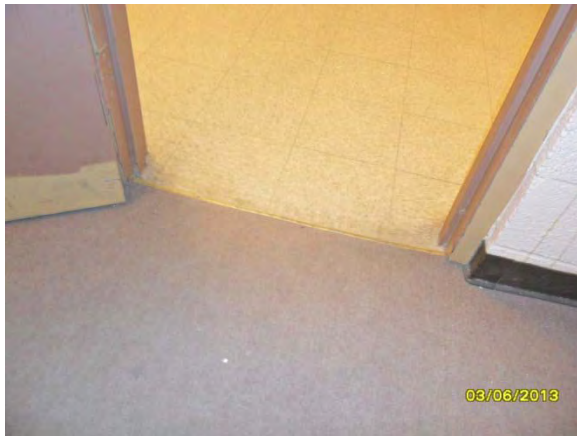
A-15. Administration Building, Transition from Main Hallway 102 to Room 111.

- Rooms 104 and 105 in the Administration Building were locked at the time of the inspection, although portions of the rooms could be observed through in-door windows, and appeared to remain as described in previous reports; and
- Room 111 in the Administration Building was carpeted. Materials under the carpeting could not be observed.

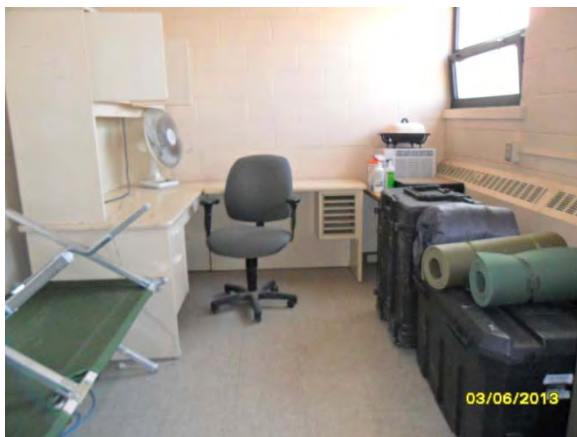
A-17. Administration Building, Room 109.

109	Concrete	Gray	Undamaged, Non-Friable	Arms Vault, concrete flooring and walls, non-ACM.
110	VCT	Light toast	Undamaged, Non-Friable	Computer server room.
111	Carpet	Dark brown	Undamaged, Non-Friable	Materials under carpet non-observed.
112	Concrete	Gray	Undamaged, Non-Friable	Mechanical Room.
113	VCT	Light toast	Undamaged, Non-Friable	Typical of VCT throughout majority of the facility. Non-ACM.
114	VCT	Light gray	Undamaged, Non-Friable	VCT is non-ACM, mastic reported as 10-20% chrysotile.
115	Ceramic Tile	White	Undamaged, Non-Friable	Men's latrine, showers and locker room, painted concrete floor, ceramic tile walls, non-ACM.
116	Concrete	Gray	Undamaged, Non-Friable	Men's latrine, showers and locker room, painted concrete floor, ceramic tile walls, non-ACM.
117	VCT	Light toast	Undamaged, Non-Friable	Typical of VCT throughout majority of the facility. Non-ACM.
118	VCT	Light toast	Undamaged, Non-Friable	Typical of VCT throughout majority of the facility. Non-ACM.

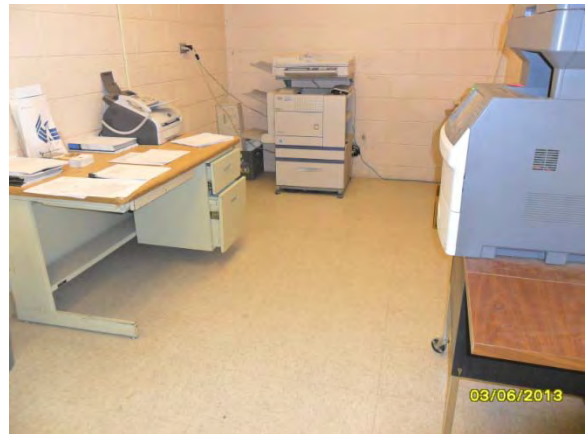
A-30. Administration Building, Room 119.

119	VCT	Light toast	Undamaged, Non-Friable	Typical of VCT throughout majority of the facility. Non-ACM.
120	VCT	Tan with black mottling	Undamaged, Non-Friable	Typical of VCT in Hallway 103 and Assembly Hall Room120.
120A	Ceramic Tile	Brick Red	Undamaged, Non-Friable	Non ACM
120B	Ceramic Tile	Brick Red	Undamaged, Non-Friable	Non ACM
120C	Ceramic Tile	Brick Red	Undamaged, Non-Friable	Non ACM
Utility Closet	VCT	Light brown	Undamaged, Non-Friable	Non ACM
OMS				
Room	Material Type	Color	Condition	Comment
South Service Bay	Concrete	Gray	Undamaged, Non-Friable	Non ACM
North Service Bay	Concrete	Gray	Undamaged, Non-Friable	Non ACM
Battery Storage	Concrete	Gray	Undamaged, Non-Friable	Non ACM
Utility Room	Concrete	Gray	Undamaged, Non-Friable	Non ACM
Parts Storage	Concrete	Gray	Undamaged, Non-Friable	Non ACM
Fluids Storage	Concrete	Gray	Undamaged, Non-Friable	Non ACM
Storage and Supply Area	VCT	Beige	Undamaged, Non-Friable	Non ACM

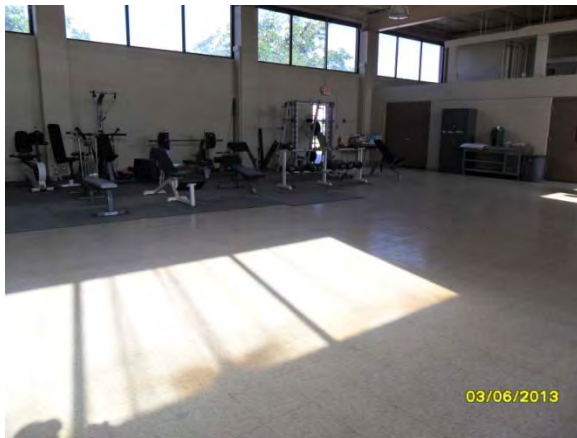
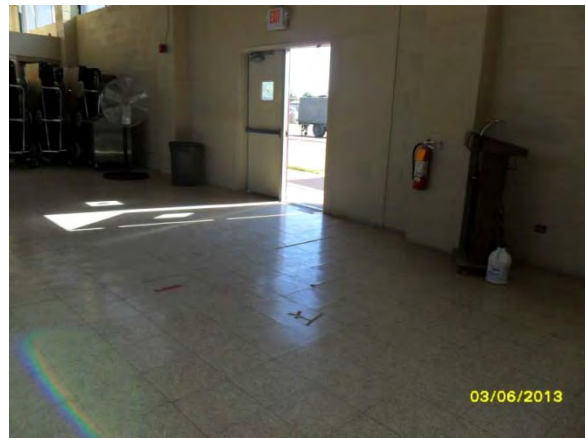
**A-31. Administration Building, Assembly Hall,
Room 120.**

Friable assumed ACM was noted in the vibration collars on the HVAC air handling units in the Administration Building Assembly Hall. Friable ACMs were not observed in the remainder of either building. Table 4-1 includes a summary of the previous and current conditions of the identified ACMs. Materials sampled in the 1993, 1997, and 2011 surveys that were found not to be ACM are not included in Table 4-1.

- Suspect ACM should be sampled and evaluated prior to disturbance during operation and maintenance or renovation, as needed;
- ACM should remain covered or properly maintained to prevent abrasion, chipping or cracking, to minimize potential for exposure; and
- Should ACM be scheduled for removal, follow all local, state and federal regulations, using appropriate containment protocols and properly licensed and certified asbestos abatement contractors and supervision.

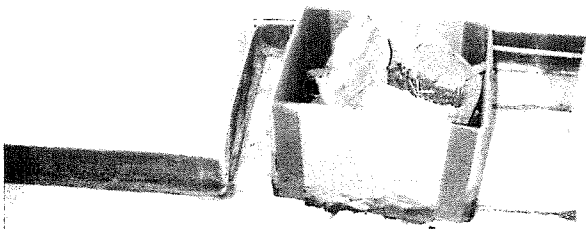
**PHOTO NUMBER
02**

SAMPLE NO.	ACM LC-001	ACM LC-002	ACM LC-003	ACM LC-004	ACM LC-005
LOCATION	MECH ROOM	MECH ROOM	RM 120	RM 120	RM 114
TYPE OF MATERIAL	PF	PI	FTM	BCM	FTM
PHOTO NO.	01	02	03	03	04
FUNCTIONAL SPACE NO.	01	01	02	02	03
CONDITION:					
% DAMAGE					0
EXTENT					D
TYPE					P
POTENTIAL DISTURBANCE:					
AIR					L
VIBRATION					L
CONTACT					L
QUANTITY					1400 SF
RESULTS	N	N	N	N	MASTIC 10-20% CHRY

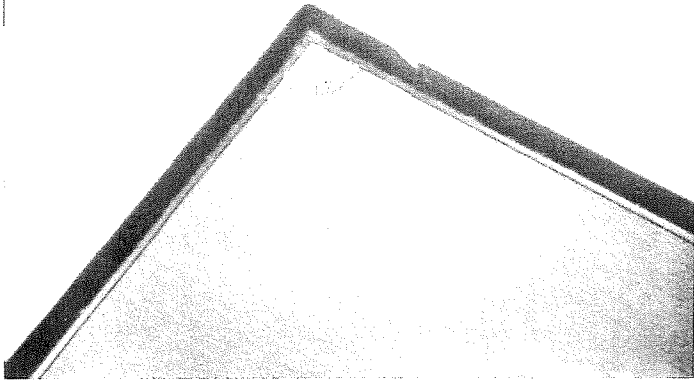
**PHOTO NUMBER
04**

SAMPLE NO.	ACM LC-006	ACM LC-007	ACM LC-008	ACM LC-009	ACM LC-010
LOCATION	RM 114	RM 111	RM 111	RM 111	RM 111
TYPE OF MATERIAL	BCM	BCM	CPT	GBCT	GBCT
PHOTO NO.	04	05	05	06	07
FUNCTIONAL SPACE NO.	03	03	03	03	03
CONDITION:					
% DAMAGE					
EXTENT					
TYPE					
POTENTIAL DISTURBANCE:					
AIR					
VIBRATION					
CONTACT					
QUANTITY					
RESULTS	N	N	N	N	N
