Group B System Site Visit Checklist

1. Name of System:		Conconully VIS		2. Date: 8/28/2010	
3. PWS I.D #		FS1355	4. County:	Okanogan	5. Phone # 509 486-5111
6: Contact Person:		Elizabeth Peterson

Group B Site Visit Checklist

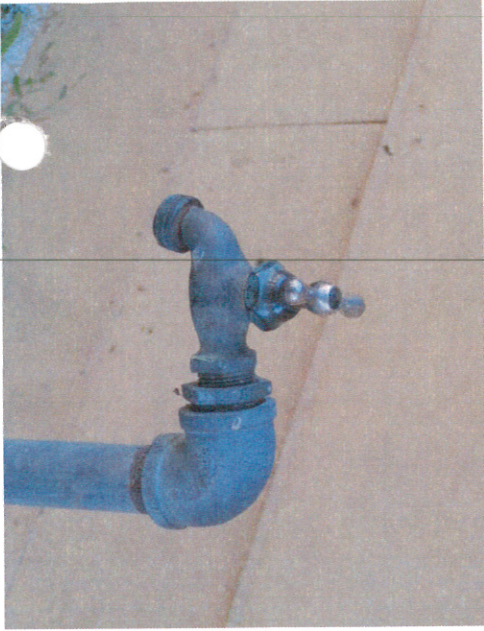
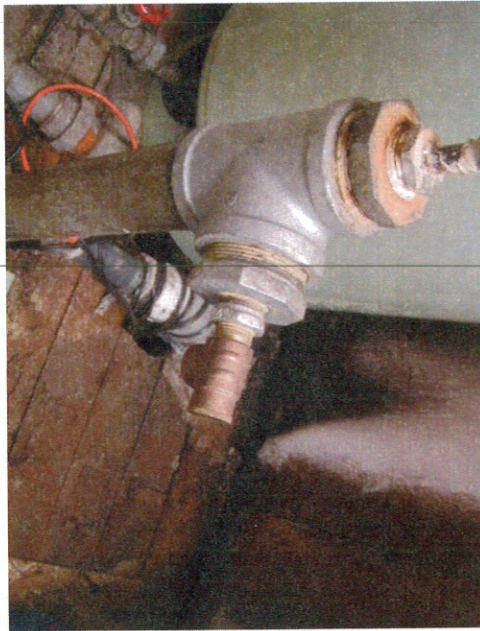
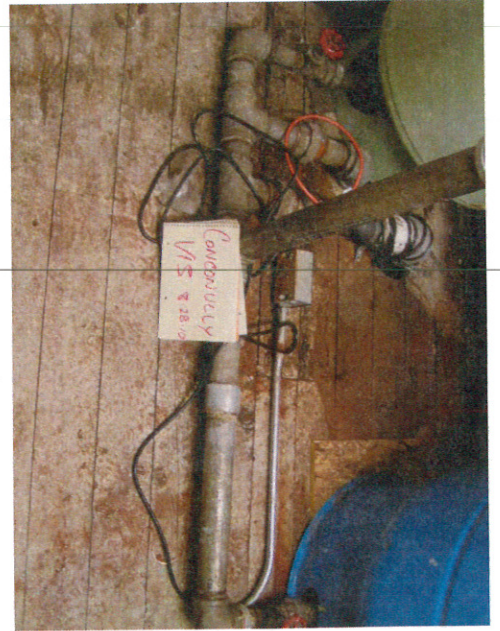
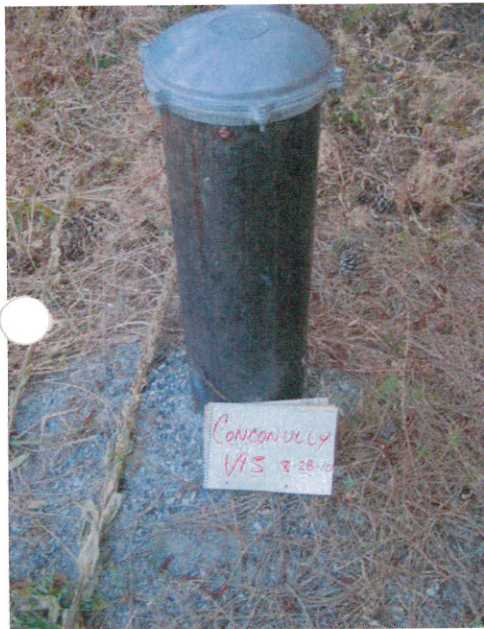
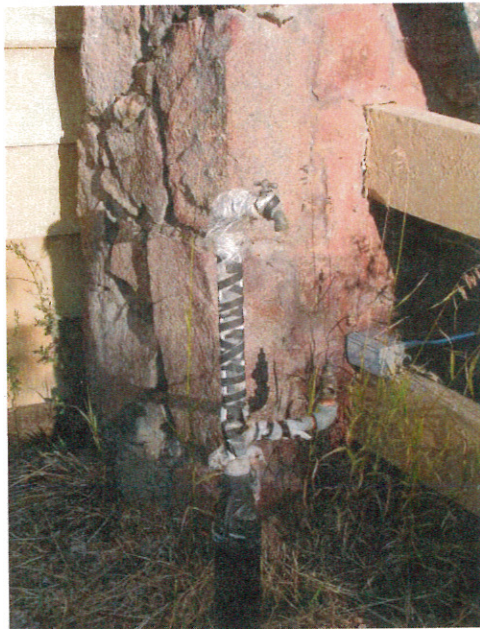
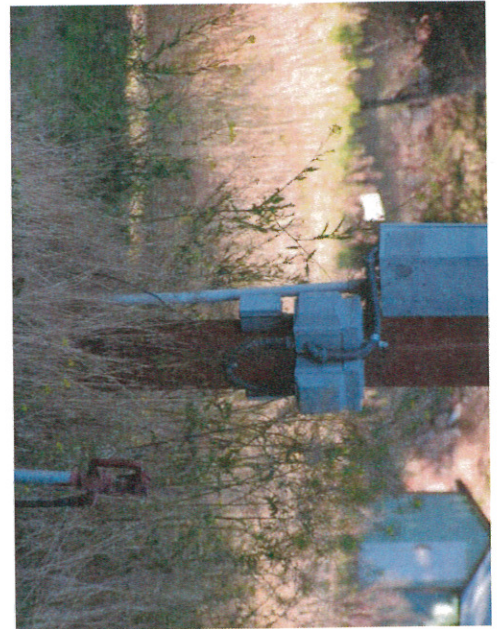
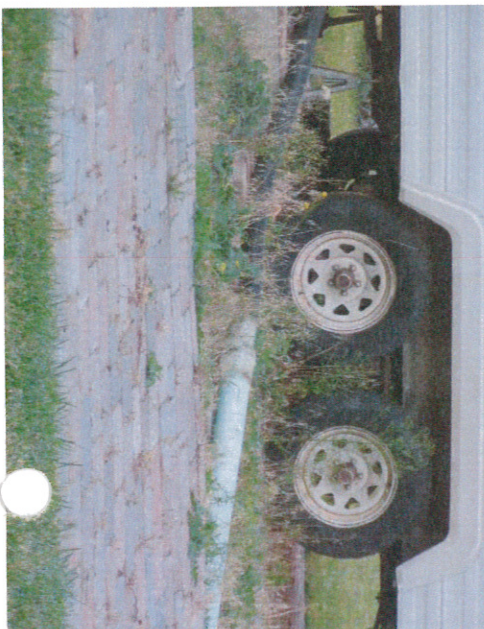
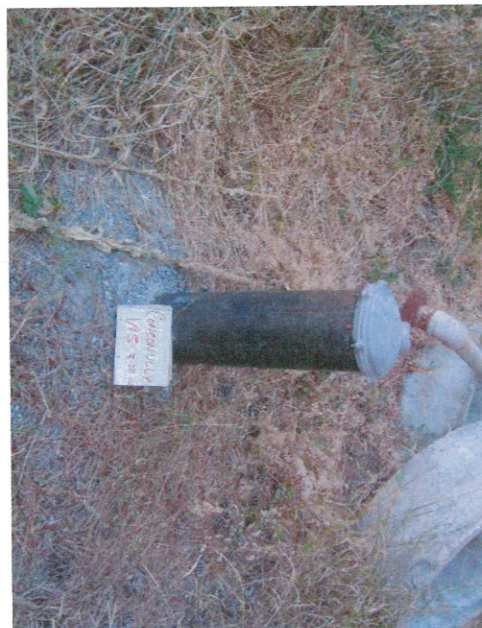
Neighbors pressure septic is within 40 ft. of wellhead.*see pictures

No tag and no screened vent.

All hose bibs need HBVB's installed, or non threaded faucet heads.
